Archaeological identification of the shipwreck site RI 2394 in Newport Harbor, Rhode Island, USA

Preliminary report

24 January 2022 [Amended 11 February 2022]

Kieran Hosty, Manager Maritime Archaeology Program
Dr James Hunter, Curator Naval Heritage and Archaeology

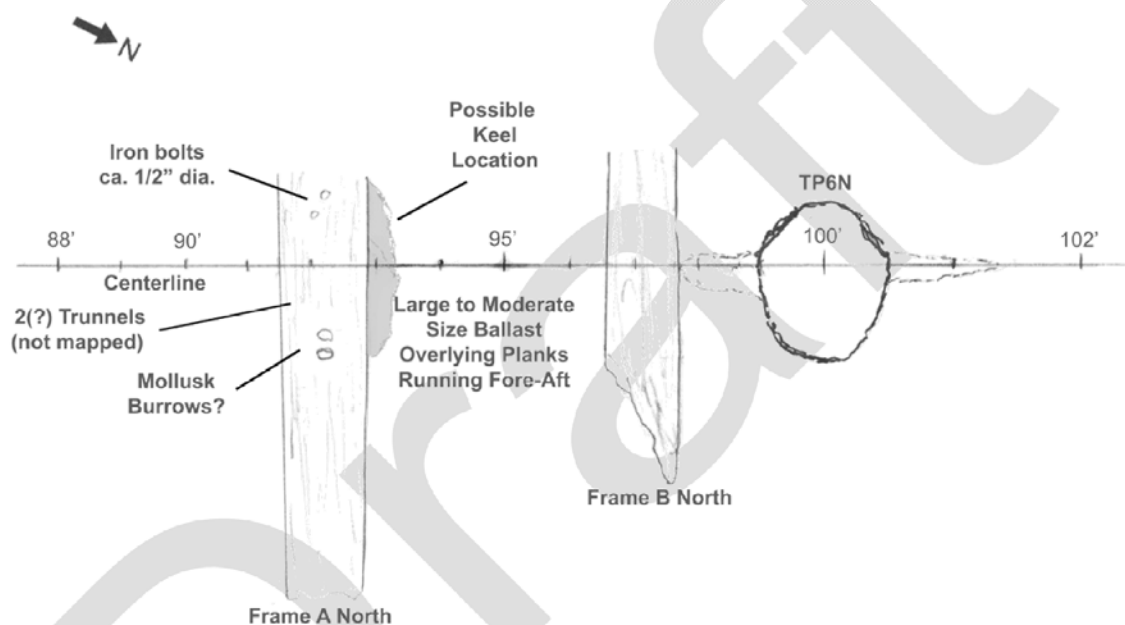
Several planks run fore and aft through TP6N on a roughly north-south orientation and are located at a depth of approximately 1 foot (0.3 metres) below grade. Those encountered beneath Frame A North were identified as hull (exterior) planking that had become disarticulated from the frame. Additional planks were encountered in TP6N and some are believed to be contiguous with the hull planking beneath Frame A North. All are approximately 1 foot below grade. Their relatively shallow burial depth, as well as that of the two frames, suggests hull preservation is very poor in this part of the site. This is supported by the lack of additional frames and other hull components (such as ceiling planking) that are likely to have become disarticulated from the hull and lost via a combination of natural and human processes.

Figure 11. RI 2394 area of concentration, October 2020 (John D. Broadwater).

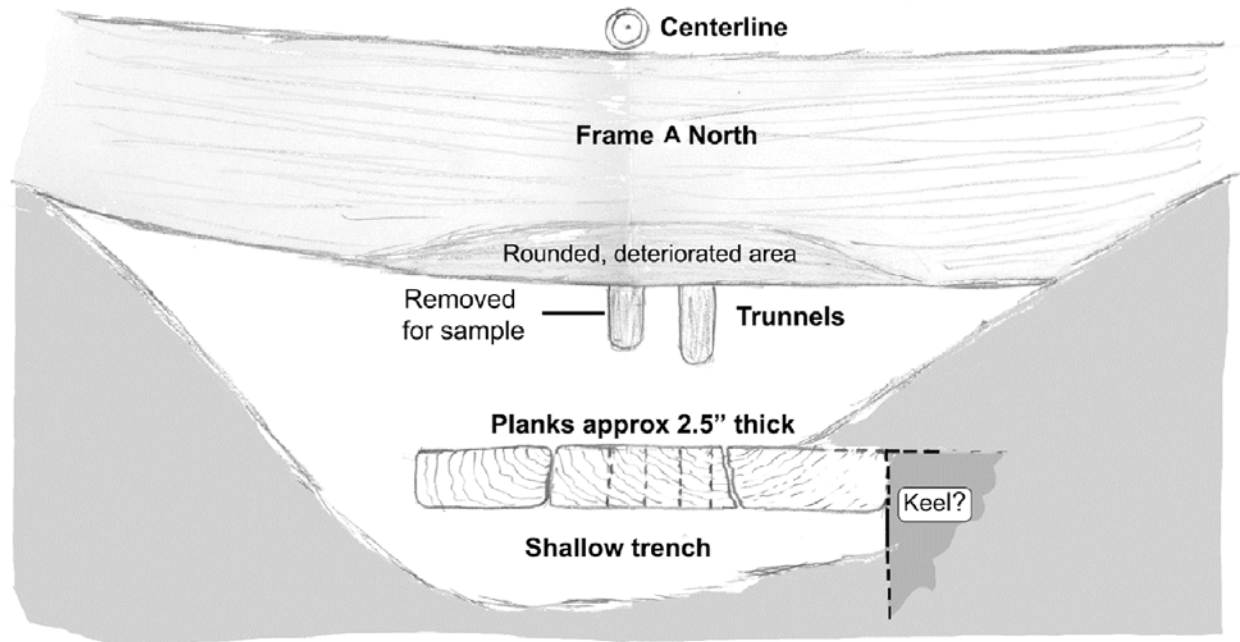
two treenails that protrude from the frame's lower sided face. Because it was assumed the site's centreline baseline was aligned with the keel, the team's initial interpretation was that the floor was attached to the keel exclusively with treenails. However, this conclusion seems unlikely, given a floor timber – even if installed as an emergency replacement – would have been affixed to the keel with more robust metal fasteners.

Figure 12. Cross-section through TP6N southern extension, at Frame A North, facing south, showing outer planking pulled free from Frame B North. Also shown is the possible keel, located on the last dive. Scale approximate. (John D. Broadwater).

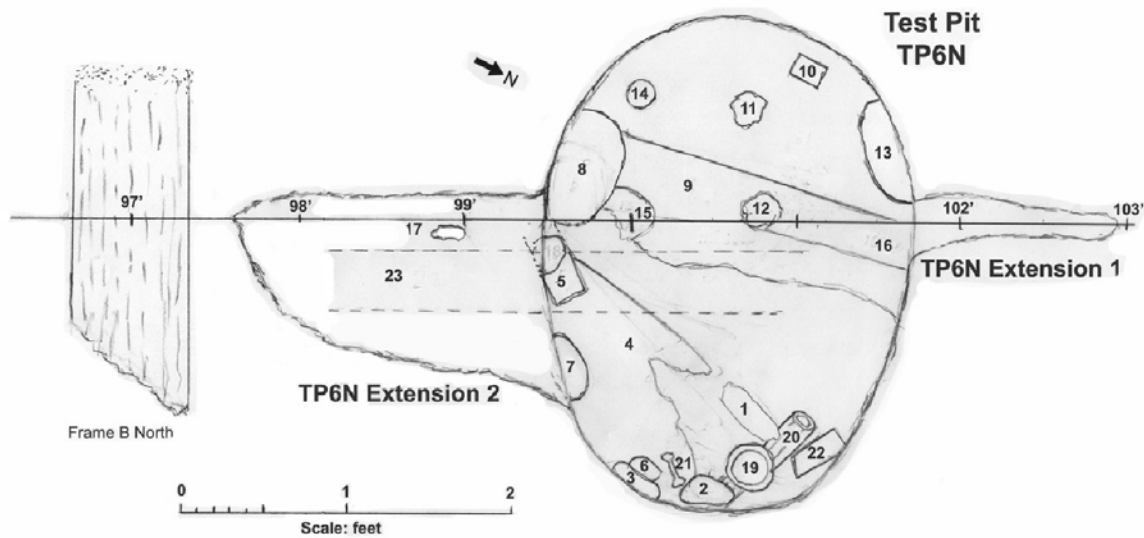
One curious feature found in TP6N is a very wide plank at the test pit's western extremity through which a 2-inch (5.1-centimetre) hole has been drilled (Object No. 14 in Figure 13). The hole does not retain staining or concretion residue that might be associated with a fastener that has since disappeared. In addition, the plank does not appear to be aligned with the run of the keel. Given its unusual size, the presence of the hole, and its proximity to the suspected location of the keel, the plank could be a limber board. Alternatively, it may be a hull plank and the hole a scuttling hole produced with a drill.

Figure 13. RI 2394: Details of test pit TP6N (John D. Broadwater).

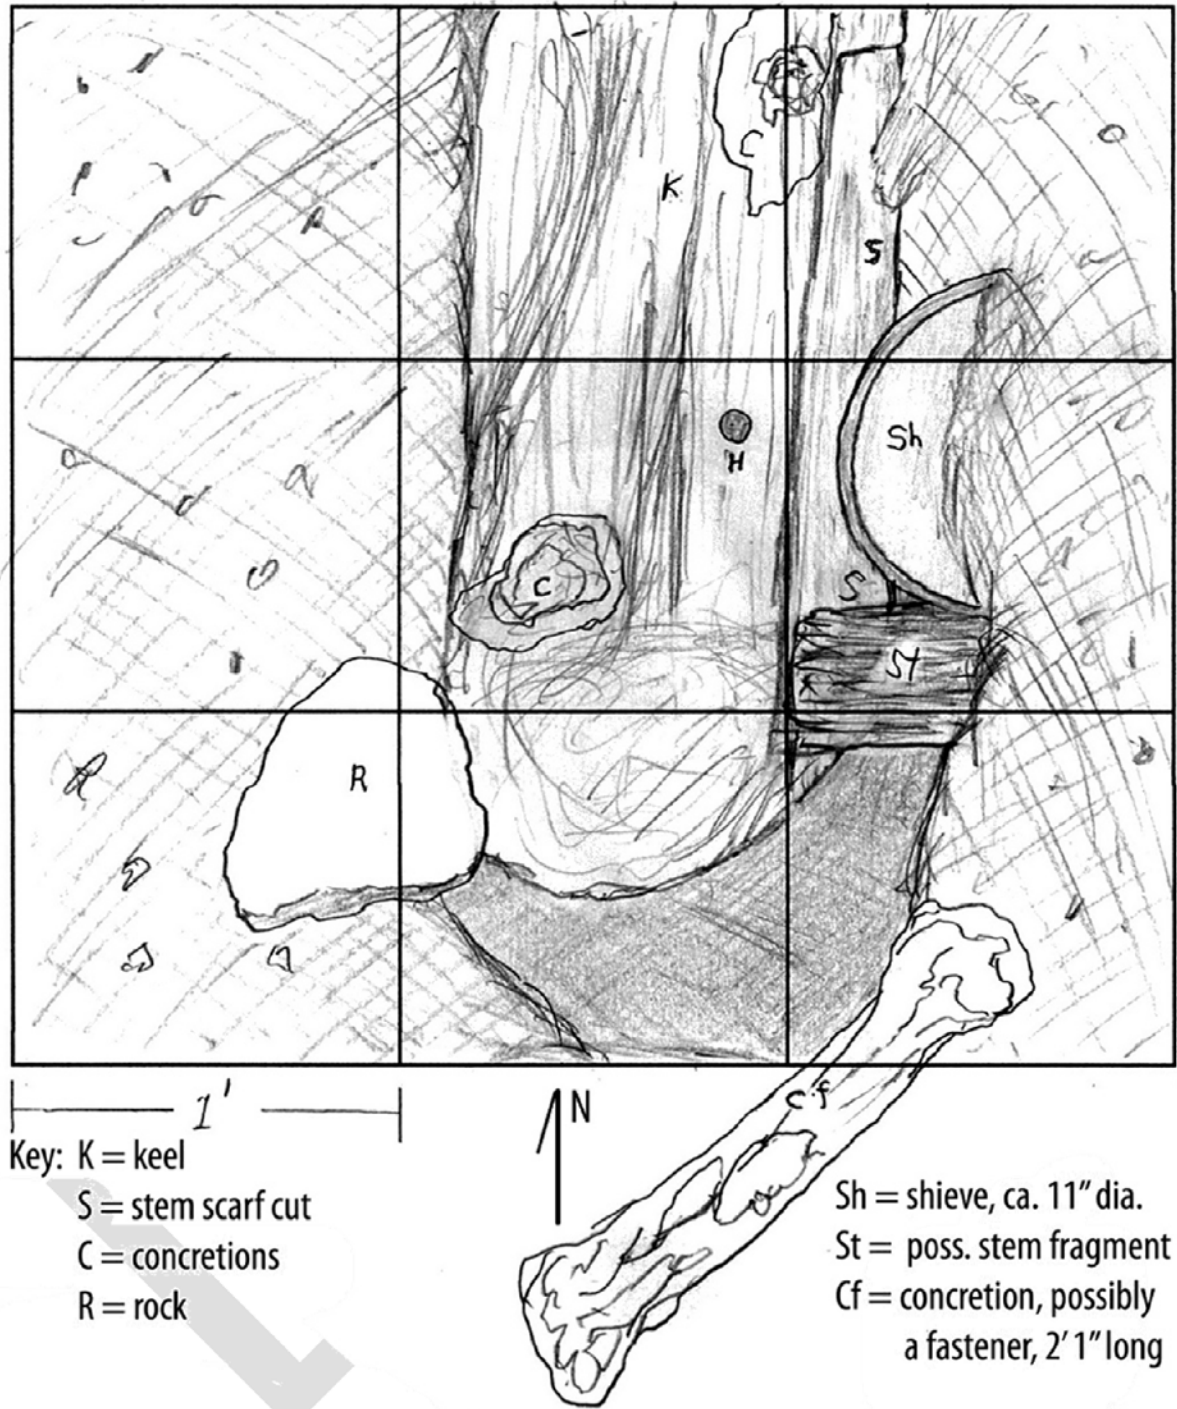
Fortunately, the keel's southern end was largely preserved and retained most of the scarph that connected it to the vessel's stem. Positive identification of the keel-stem scarph confirmed that RI 2394's bow faces south (see Figure 14 and Figure 15). The stem was absent, save for a small remnant timber fragment found lying within the scarph.

Figure 14. South end of keel, showing stem-keel scarph in plan view. Note that north is up (John D. Broadwater).

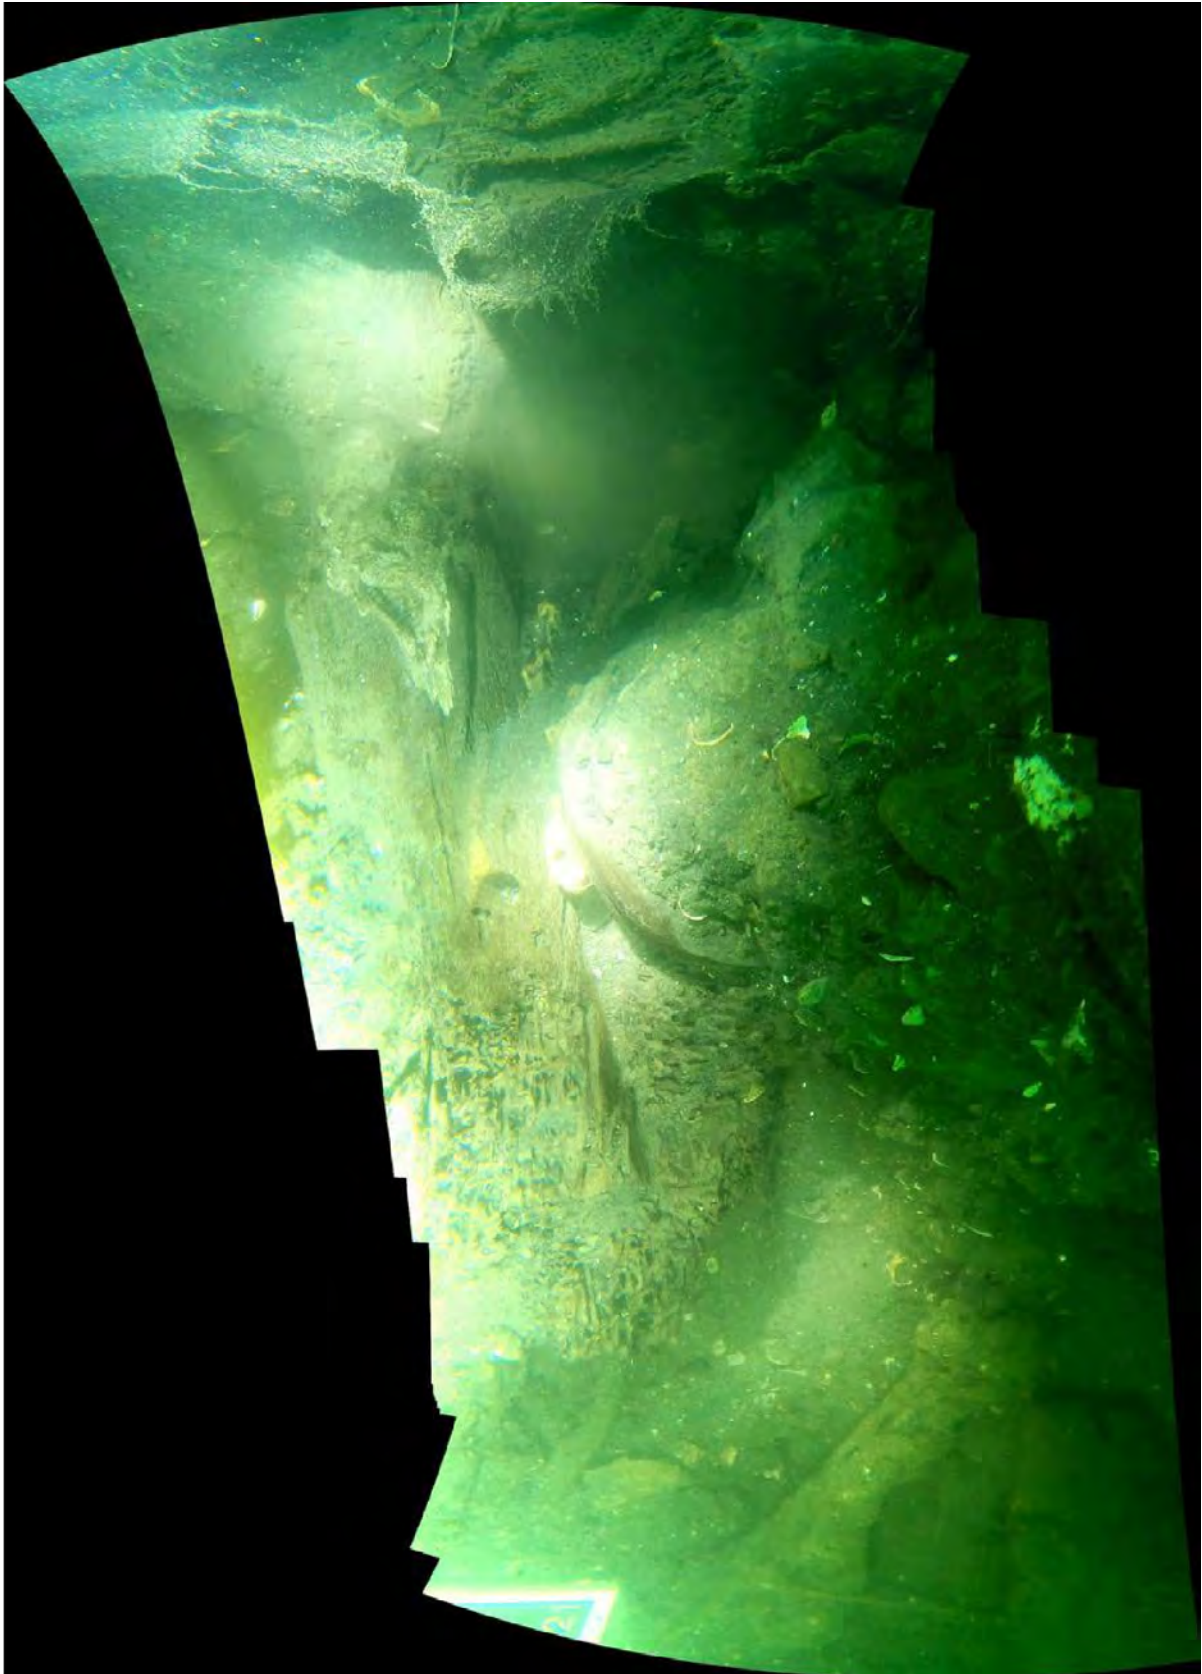
Figure 15. Photomosaic of keel's southern terminus, showing scarp for the stem (beneath wooden sheave at image centre). Note that north is up (John D. Broadwater and Joshua Daniel).

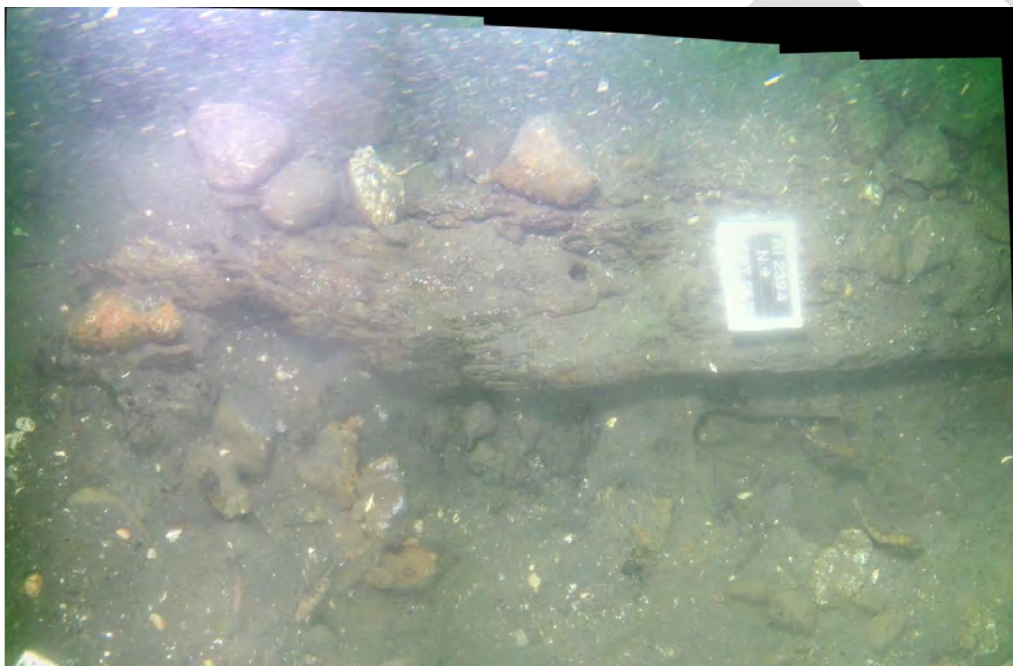
A shallow trench (Test Pit 10-North) was excavated adjacent to the northern moulded face of the frame located at 29.2 metres (96 feet) on the centreline baseline. While the objective was to locate the keel, the trench instead revealed at least six hull planks to the west of the baseline, two of which featured a scuttling hole (Figure 20, Figure 21 and Figure 22). The hole is located at the 29.56-metre (97-foot) mark on the centreline baseline and is offset 1.37 metres (4 feet 6 inches) (Figure 22).

Figure 20. Mosaic showing frame and scuttling hole beneath letter board, north to bottom (John D. Broadwater).

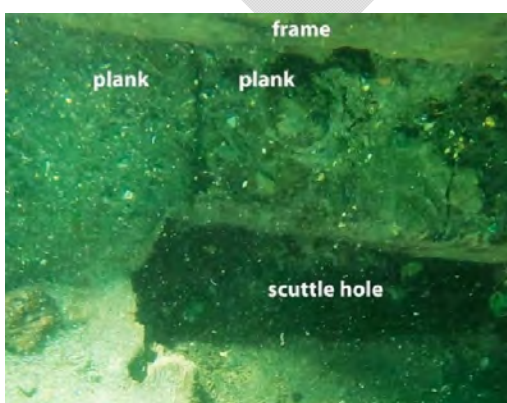
Figure 21. Close-up image of scuttling hole on the north side of the keel (John D. Broadwater).

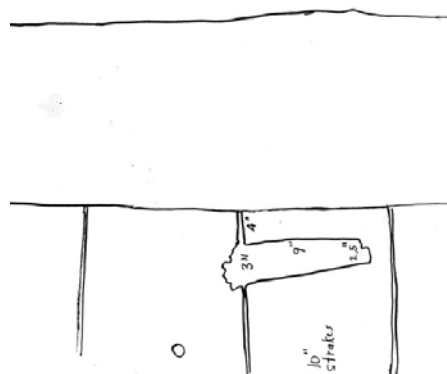
Figure 22. Sketch of scuttling hole (plan view, north to bottom)(John D. Broadwater).
