Archaeological identification of the shipwreck site RI 2394 in Newport Harbor, Rhode Island, USA

Preliminary report

24 January 2022 [Amended 11 February 2022]

Kieran Hosty, Manager Maritime Archaeology Program
Dr James Hunter, Curator Naval Heritage and Archaeology

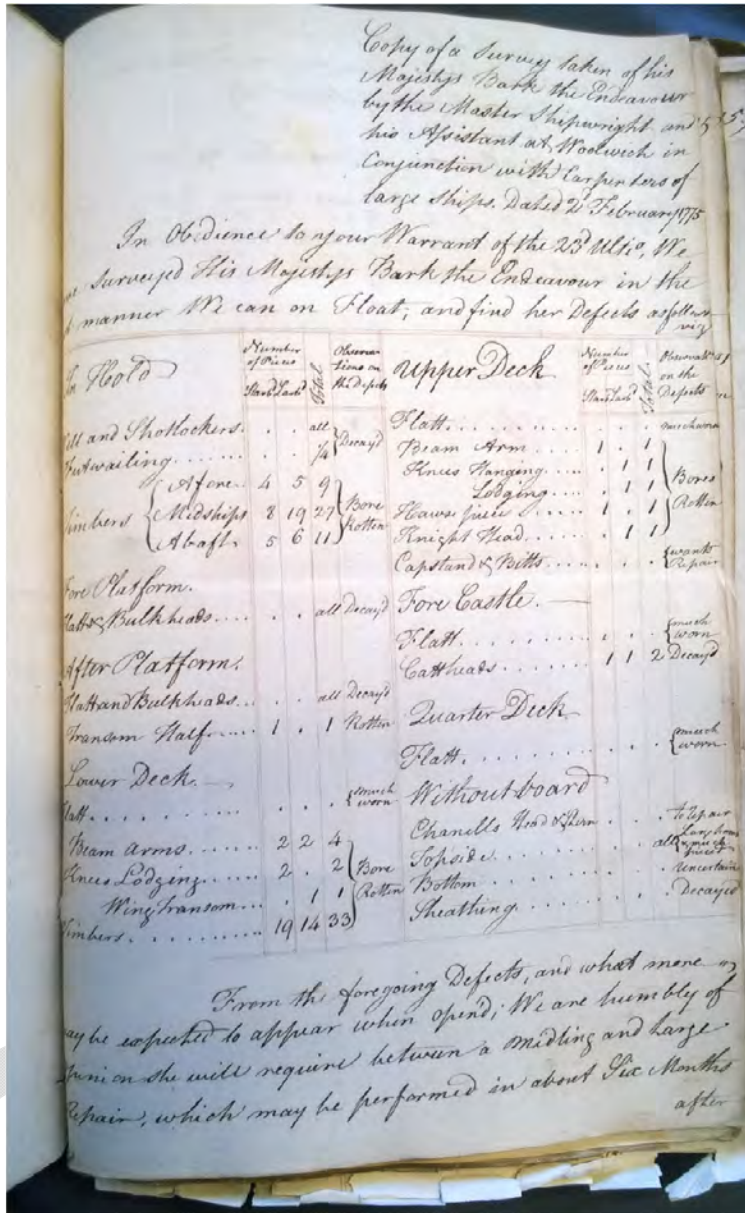
² ADM 354/189/330 notes the following timbers were rotten and needed to be replaced: in the bow, four timbers (frames) on the starboard side and nine timbers on the larboard (port) side; at midships, eight timbers on the starboard side and 19 timbers on the larboard side; and at the stern, five timbers on the starboard side and six timbers on the larboard side. This constituted 47 timbers in total, or around 36% of the lower hull.

Figure 1. Report to the Admiralty noting the significant repairs required in 1775 to keep *Endeavour* operational and seaworthy (ADM 354/189/330 Navy Board: Bound Out-Letters: Woolwich; National Archives, Kew).

The master shipwright at Woolwich stated *Endeavour* required 'large repairs' that would take around six months to complete and cost approximately £3,420. Upon receiving the report, the Navy Board recommended the vessel be sold out of service, and in March 1775 master mariner George Brodrick purchased it for £645 (Erskine 2017: 59-61; Knight 1933: 299–300). The 1776 edition of *Lloyds Register* states that *Endeavour*, a ship-rigged vessel of 350 tons built at Whitby in 1764, is 'Now the *Lord Sandwich*; owner James Mather; Blanchard – Master, sailed from Archangel (Russia) for London' (Erskine 2017: 61-3).

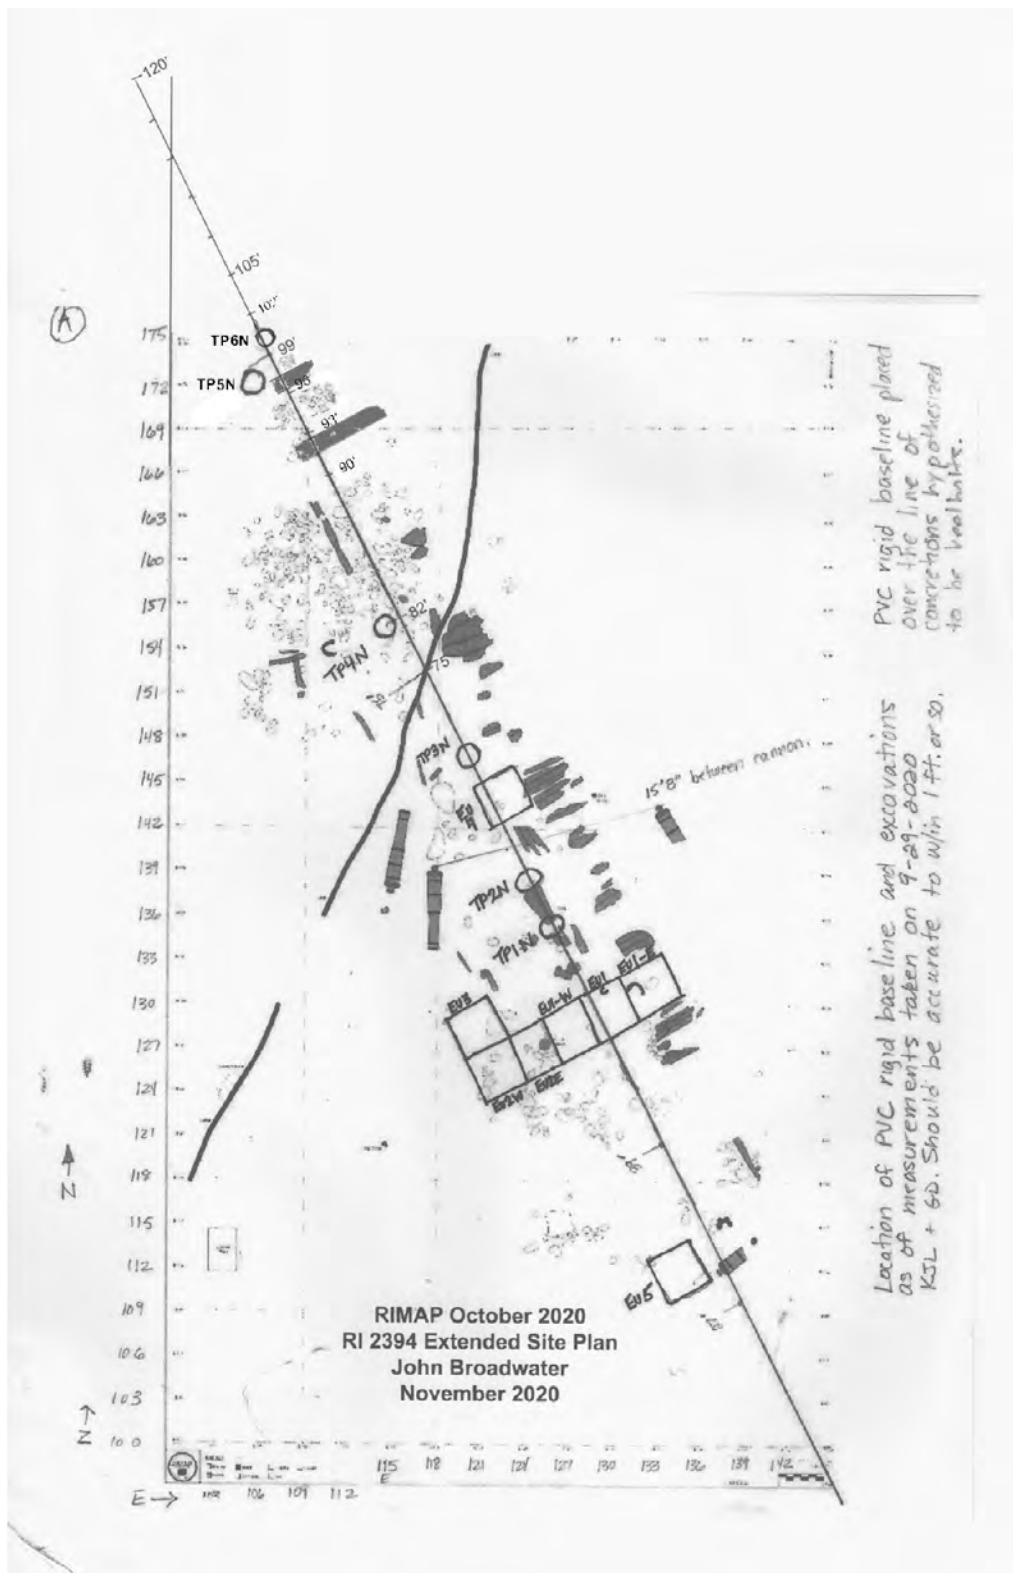
Fieldwork conducted during September and October 2020 revealed a significant number of large- and medium-sized ballast stones, numerous iron concretions, and a few small finds. Figure 10 and Figure 11 show the areas on the site where the expedition team focused most of its efforts.

Figure 10. RI 2394 Site Map Showing October 2020 work area (RIMAP site map, with additions by John D. Broadwater).

Two frames were uncovered at the northern extremity of the site, initially identified as floors, and designated Frames A and B North. No evidence of the keelson was encountered within the test pit (Test Pit 6 North, or TP6N) excavated closest to the frames. While originally

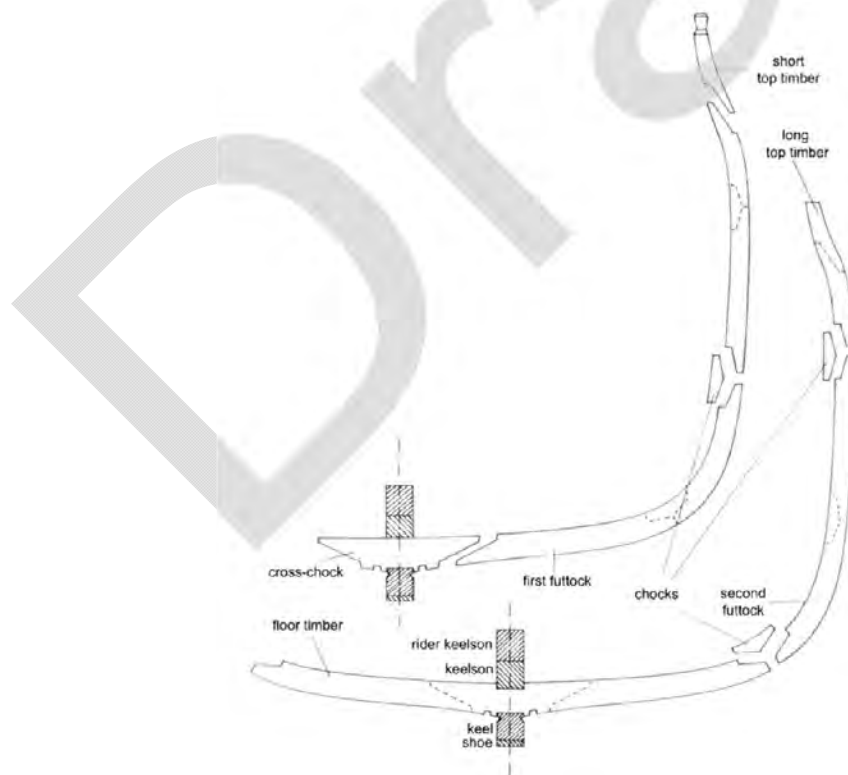
Marquardt (1995) depicted *Endeavour's* keel as being assembled from three parts joined by two vertical scarphs, each of which measured 5 feet in length. If correct, this characteristic could be diagnostic, as each scarph might be observed from above as a seam dividing the upper sided surface of the keel at its centre for a length of 5 feet. However, the ability to locate the scarphs would require knowledge of the position of either end of the keel.

Figure 32. *Endeavour* framing schematic (Marquardt, 1995: 51).

Marquardt also illustrated what Broadwater (2020) believes is an uncommon method of constructing ship's frames. He drew frames formed from bolting a short timber (called a 'cross-chock') over the keel. The cross-chock was then scarphed to two longer timber arms that he termed floor timbers (Figure 32). The frames are drawn by Marquardt as compound

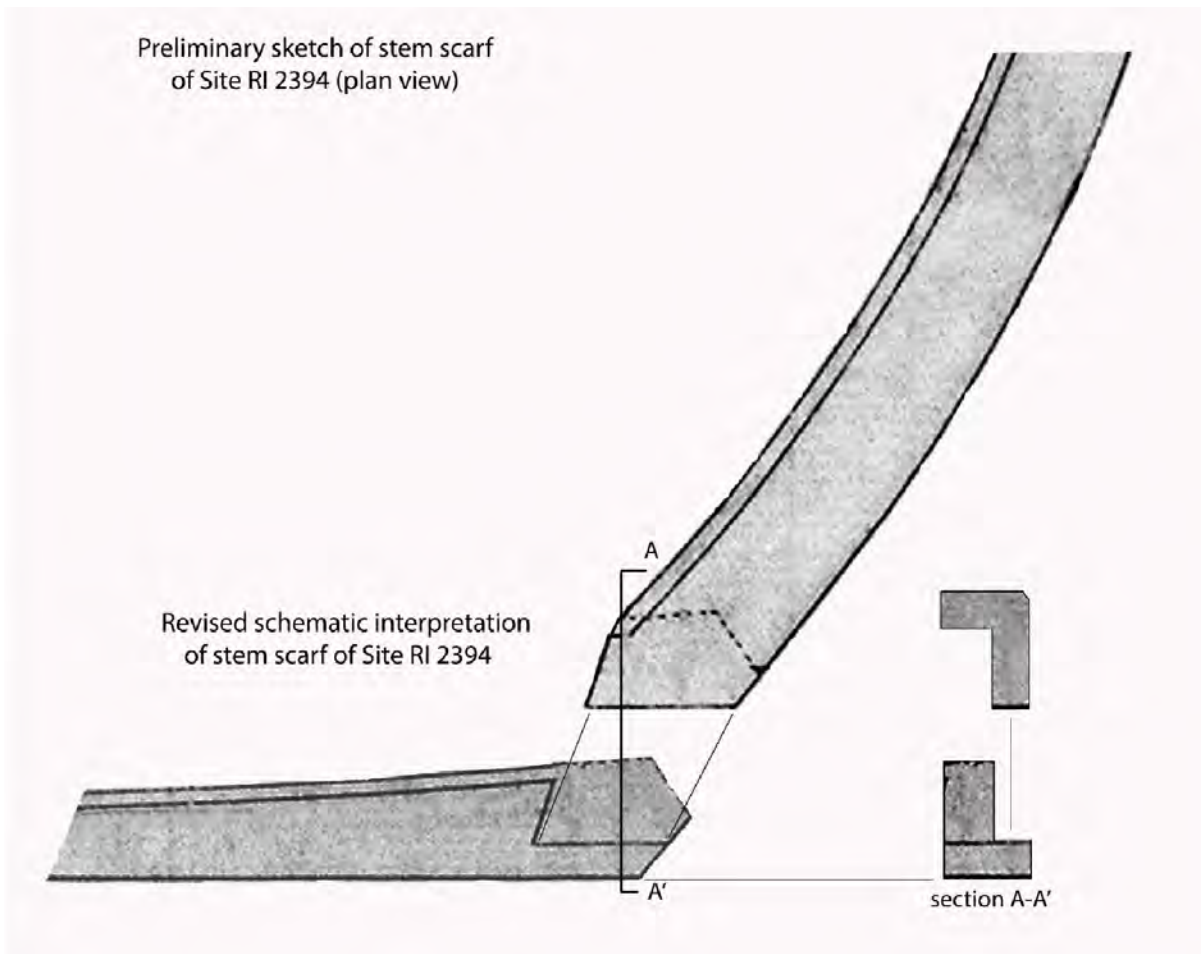
Figure 16. Reconstruction of RI 2394's stem scarf (John D. Broadwater)

The survival of the keel-stem scarf – a highly diagnostic feature – is important for two reasons. First, it permitted the project team to obtain a key measurement from the stem end of the keel to the projected location of the mainmast, a value of approximately 15.17 metres (49 feet 10 inches). Second, it provided details of the scarf itself, which appears to be a rare form of stem attachment, as discussed below. The location of the bow end of the keel was very close to its predicted position, based on superimposition of RI 2394's 2019–20 site plan with the 1768 Admiralty plan (Admiralty Draught No. 3814(b), 28 March 1768).

The extant forward end of the keel measures 33 centimetres (13 inches) sided. The 0.60-metre (2-foot) long scarf was let into the keel to a depth of 10 centimetres (4 inches). It measures 15 centimetres (6 inches) wide at its forward preserved edge and 5 centimetres wide (2-inches) aft, creating a 'wedge' shape when viewed in plan. The presence of a large wooden sheave atop the approximate middle of the scarf limited the extent to which it could be excavated, so it is presently unclear whether the wedge shape is due to natural processes or a result of intentional manufacture (Figure 16).

During the mid-to-late 18th century, British shipwrights had established accepted methods for joining the keel to the stem. However, RI 2394's keel-stem scarph is markedly different from the 'table' and 'box' scarphs typically employed during this period. When RI 2394's keel-stem scarph (Figure 16) is compared with the scarph shown in the Admiralty plans of *Endeavour* (Figure 23), there is no question they match exactly in both form and dimensions. As illustrated Figure 24, Marquardt (1995:49) depicts the same scarph (#16) and shows it braced with a horseshoe plate (#15). A similar scarph design was also used during construction of the *Endeavour* replica in 1994. This vessel is now in the ANMM collection (Figure 25 and Figure 26).

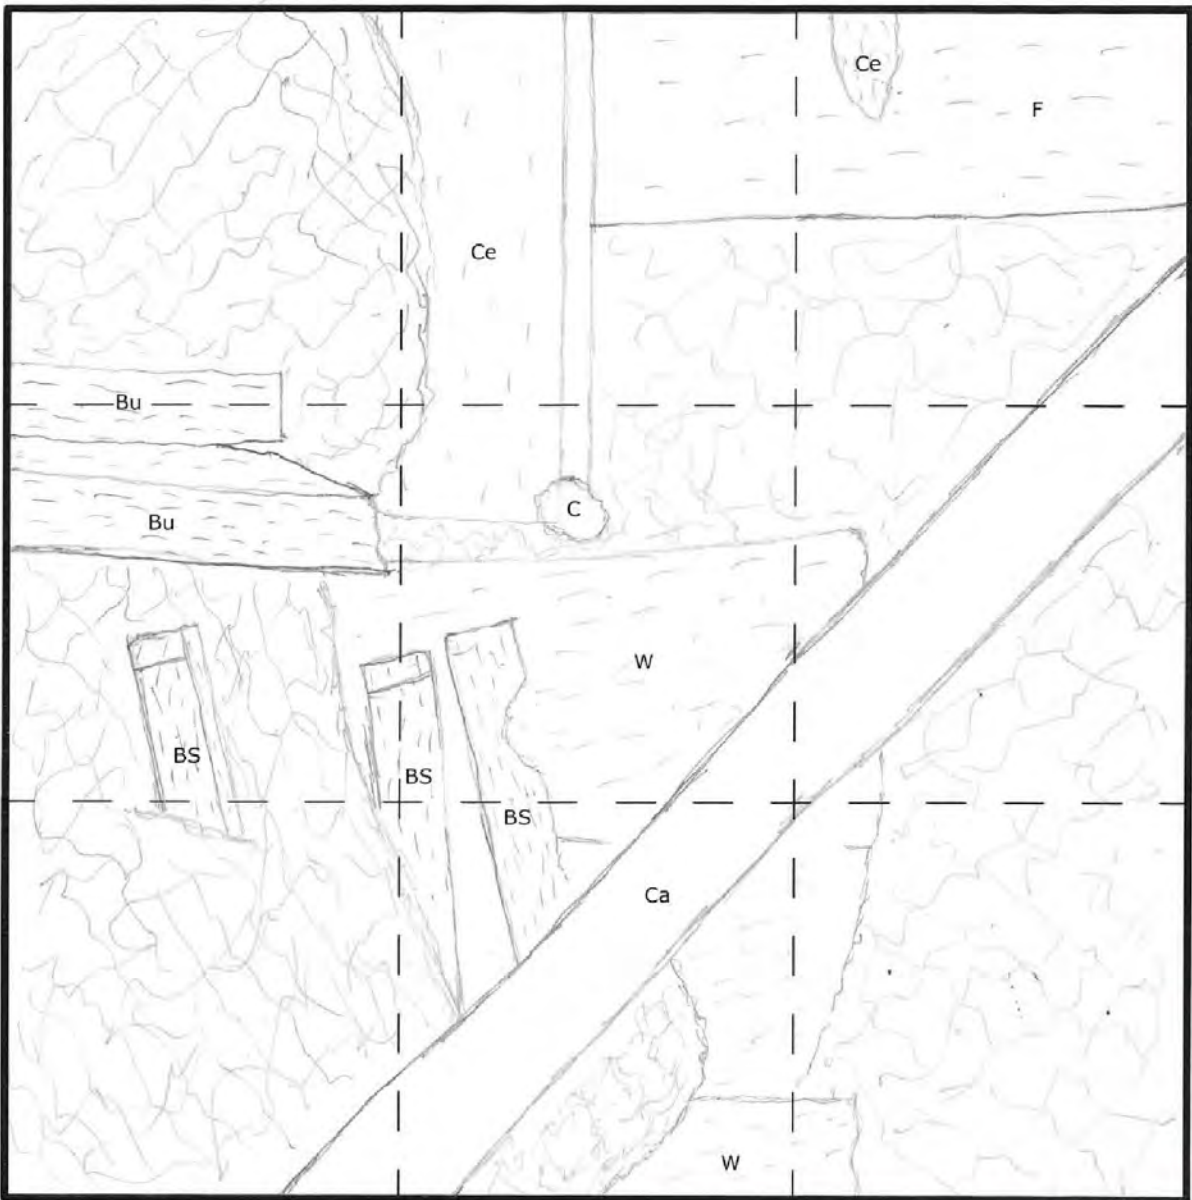
It is possible further excavation could reveal holes cut in the ceiling to accommodate the suction tubes or a pump sieve – also referred to as a 'basket' (ADM 3814b; Marquardt 1995: 71). However, further excavation of the pump well was discontinued, as exposing a larger and deeper area was thought to exceed the terms of the RIHPHC permit. A large area within and forward of the pump well was exposed and carefully mapped (Figure 17 and Figure 18). Scaled plan view sketches, drawn with a 3-foot x 3-foot mapping grid, will add more detail to the overall site plan and provide a starting point for future excavations in this area.

Following the 2021 excavation of the pump well, Erskine (2021: 6) shared additional archival research that revealed *Endeavour's* four bilge pumps were removed prior to the vessel being sold out of service in 1775. Further, none had been replaced by the time George Brodrick took possession of the vessel (ADM106/1226/154). There is no known record indicating the four pumps were returned to Brodrick, but it is likely he reinstalled at least two pumps (as per normal practice on merchant ships during the 18th century) to meet survey requirements for the Board of Transport. This in turn could account for the absence of a second starboard bilge pump shaft on RI 2394.

Figure 17. Pump well test pit, north section (Joshua Daniel).

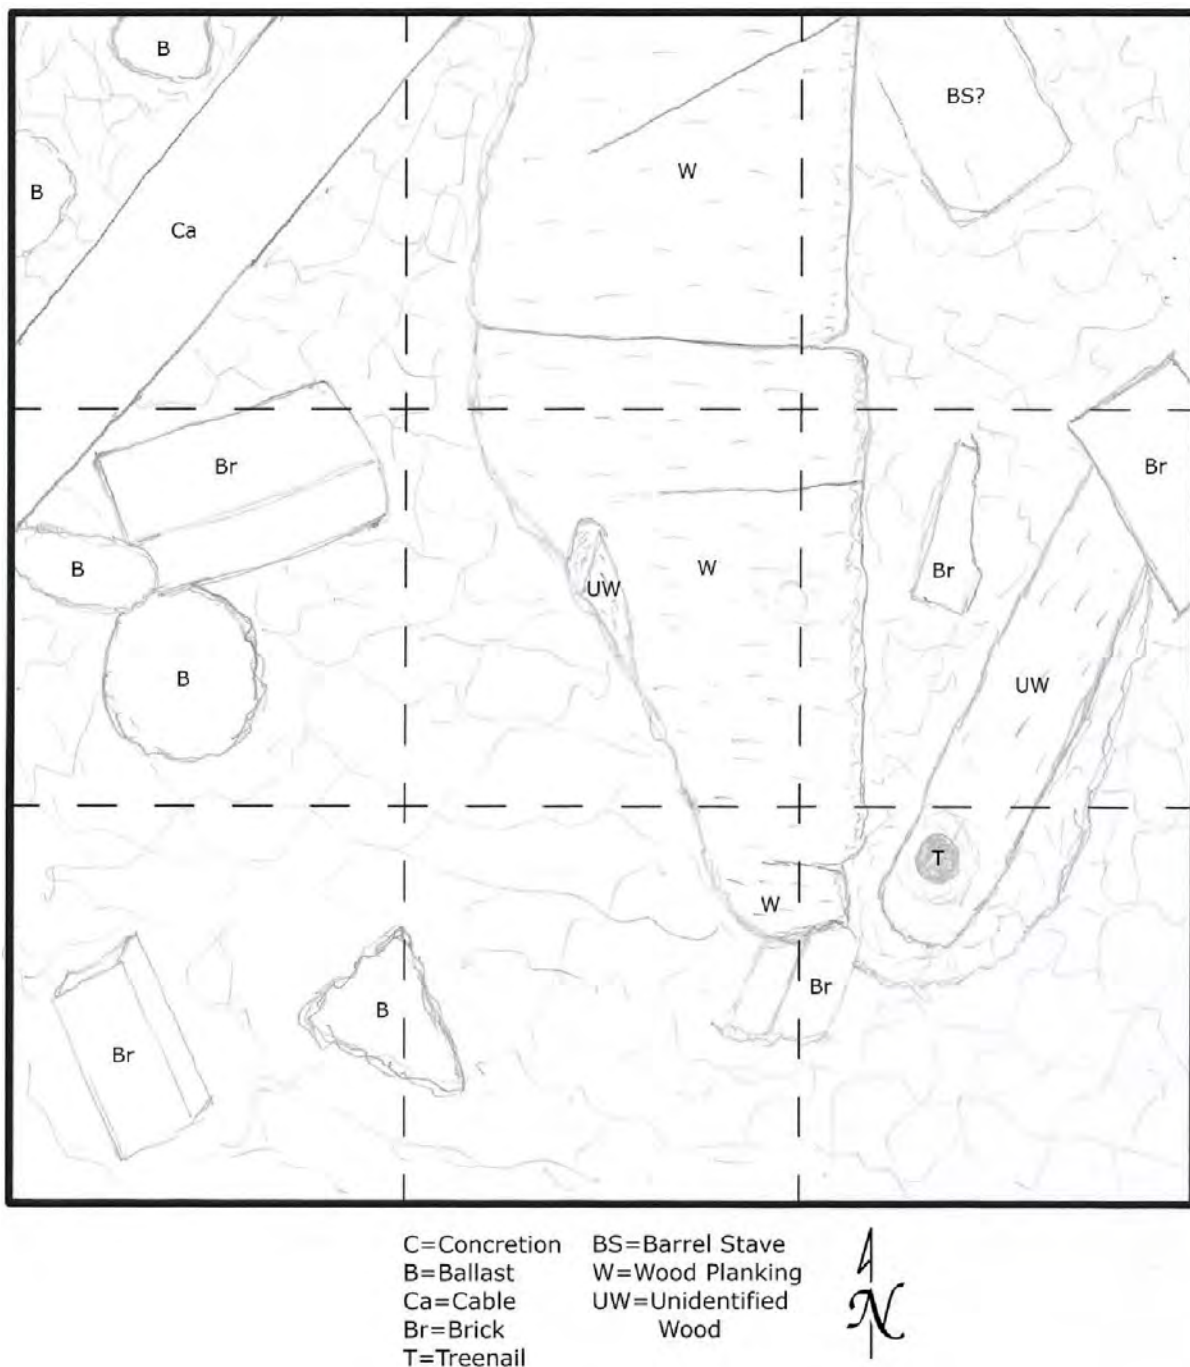
Figure 18. Pump well test pit, south section (Joshua Daniel).

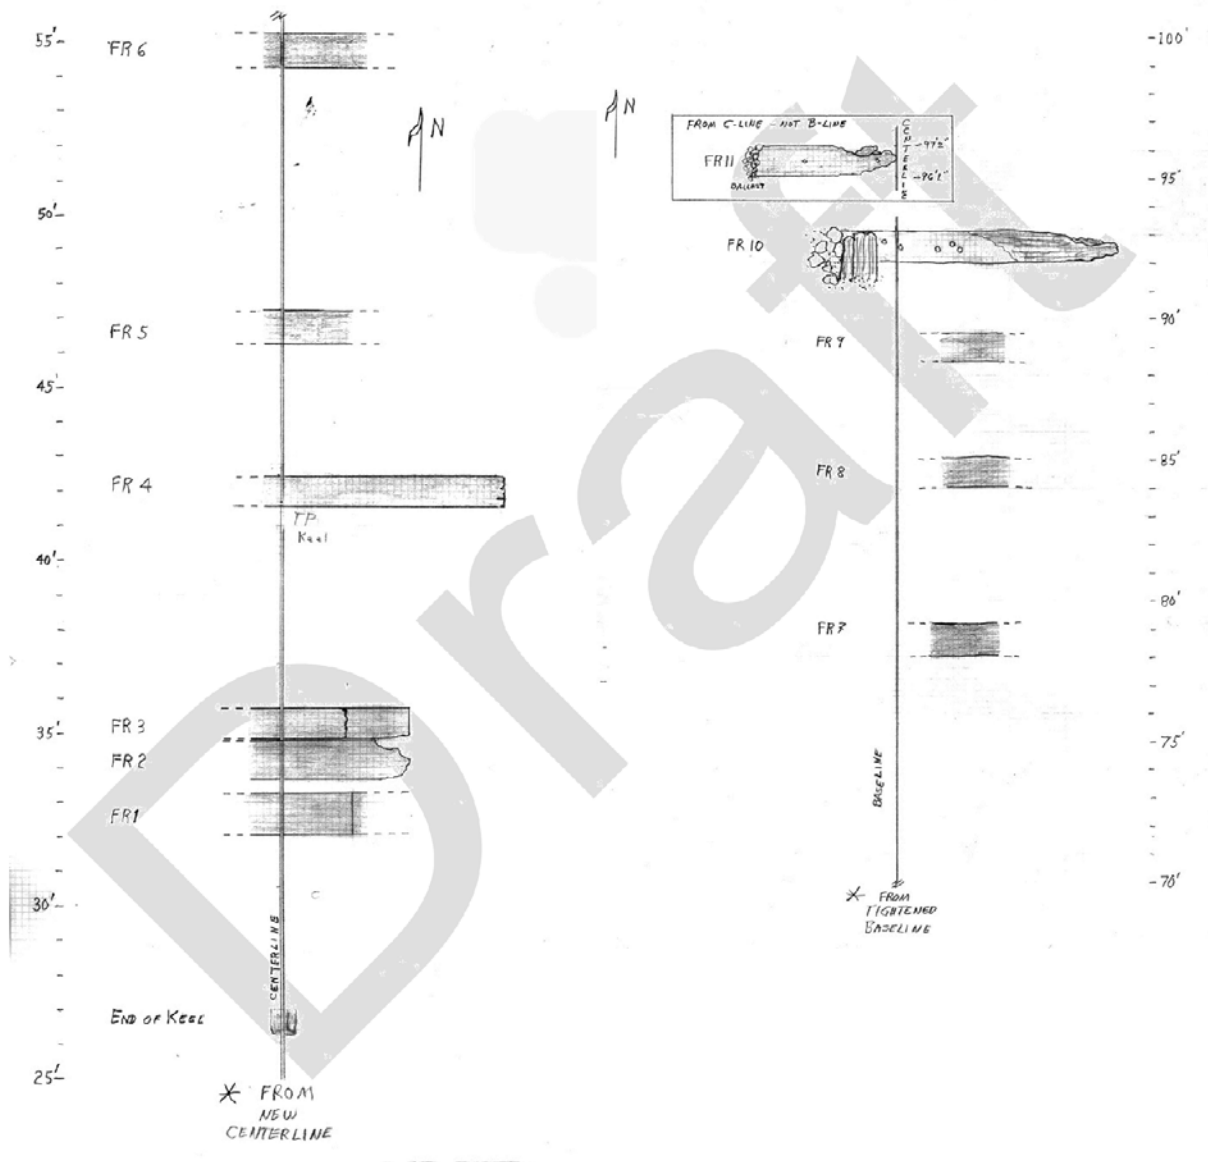
The new centreline baseline installed during the 2021 field season closely follows the line of the keel. However, both the original and new baselines were used, where applicable, to define the locations of RI 2394's hull features and artefacts. When time permitted, exposed frames were mapped with the use of either the original or new centreline baseline as a guide. Figure 19 shows the resulting framing plan. This plan should not be considered complete or entirely accurate, as the mapping of frames was not a primary goal of the 2021

investigations. It is included here to provide a general indication of how many of the wreck site's frames are missing or buried.

Figure 19. Locations of exposed frames, set against the new baseline (left) and the tightened original baseline (right) (John D. Broadwater).

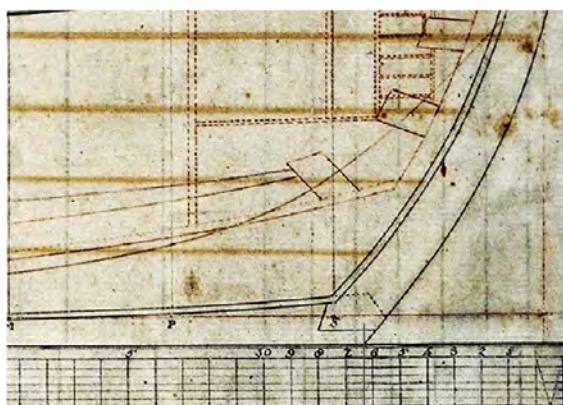
Figure 23. Detail of 1768 Admiralty draught showing Endeavour's unusual keel-stem scarph (National Maritime Museum No. 3814b, 28 March 1768).

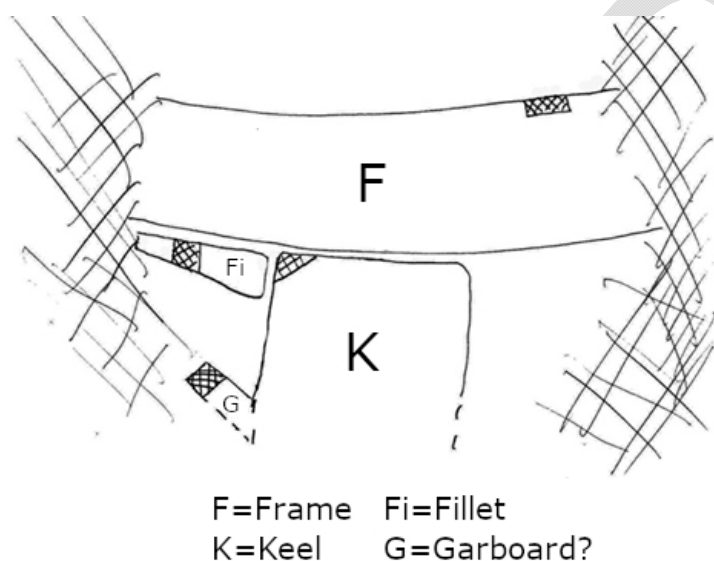
In September 2021, wood samples were recovered from four hull members in Test Pit 3-South (TP3-S): the keel, a floor timber, a fillet, and possible garboard strake (Figure 28). When a possible repair in the form of an unusual keel scarph was located in TP3-S, another sample was recovered from the keel in Test Pit 4-South in an effort to identify possible use of Indonesian timbers in repairs to the keel.

Figure 28. Locations where wood samples were recovered from TP3-S, facing north (John D. Broadwater).

The timber samples allocated for analysis in Australia were in transit at the time of writing. According to RIMAP's timber specialist, Dr Lee Newsom, all recovered timber samples fell within the White oak group, as shown in Table 12.

Although Newsom found no evidence of non-European (e.g., Australian and/or Southeast Asian) timbers among the five samples, the presence of two white oak keel samples from RI 2394's bow section does raise interesting questions. Given samples recovered from the keel in the wreck site's midships area were identified as European elm, the presence of white oak keel sections on either side of a scarph in the extreme forward end of the vessel is strongly suggestive of repair to the hull. Further, as 18th-century British shipwrights typically preferred elm over oak for keel timber, the presence of oak in the forward keel hints that its use may have been influenced by haste and/or cost-cutting measures.
